**CORROSION TESTS OF LITHIUM FLUORIDE
IN CONTACT WITH COLUMBIUM ALLOYS**

TOPICAL REPORT II

LITHIUM FLUORIDE BELLOWS CAPSULE TESTS

January 29, 1970

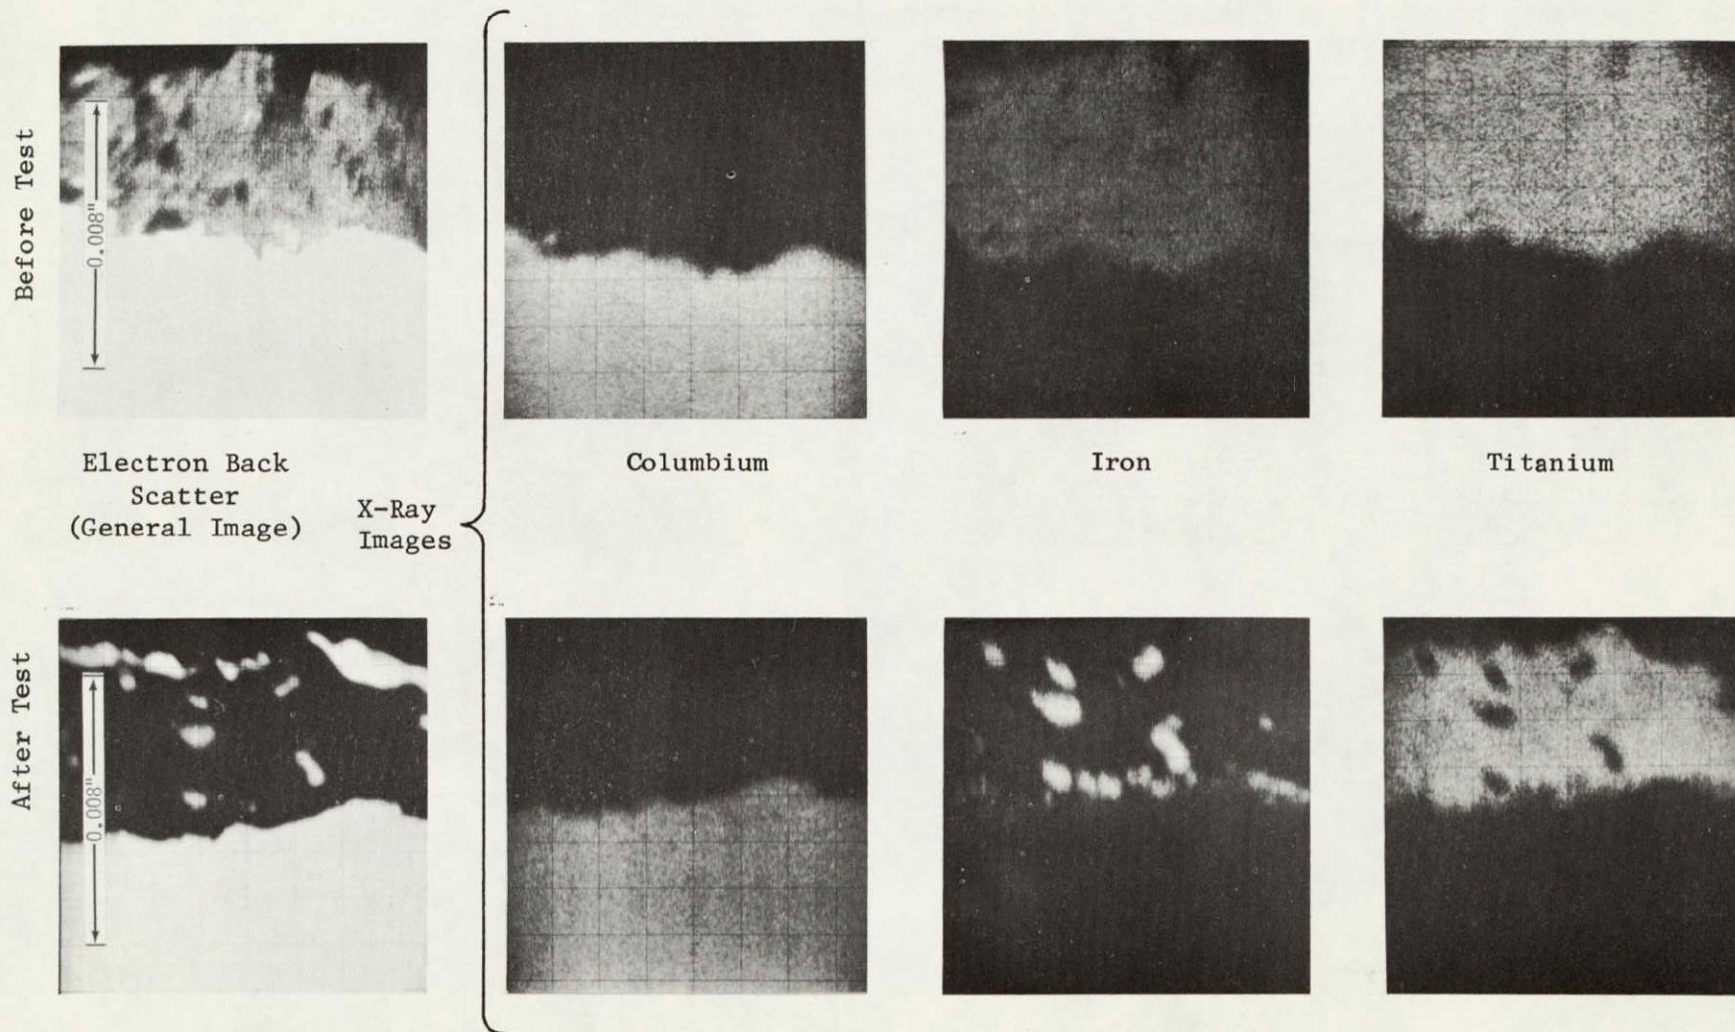
Figure 60. Electron Microprobe Oscillograms Showing the Distribution of Elements in Iron Titanate Coated Cb-1Zr. Specimens were Removed from the Wall of Bellows Capsule II After 3000 Hours of Testing - 1875 Thermal Cycles Between 1500 and 1700°F.

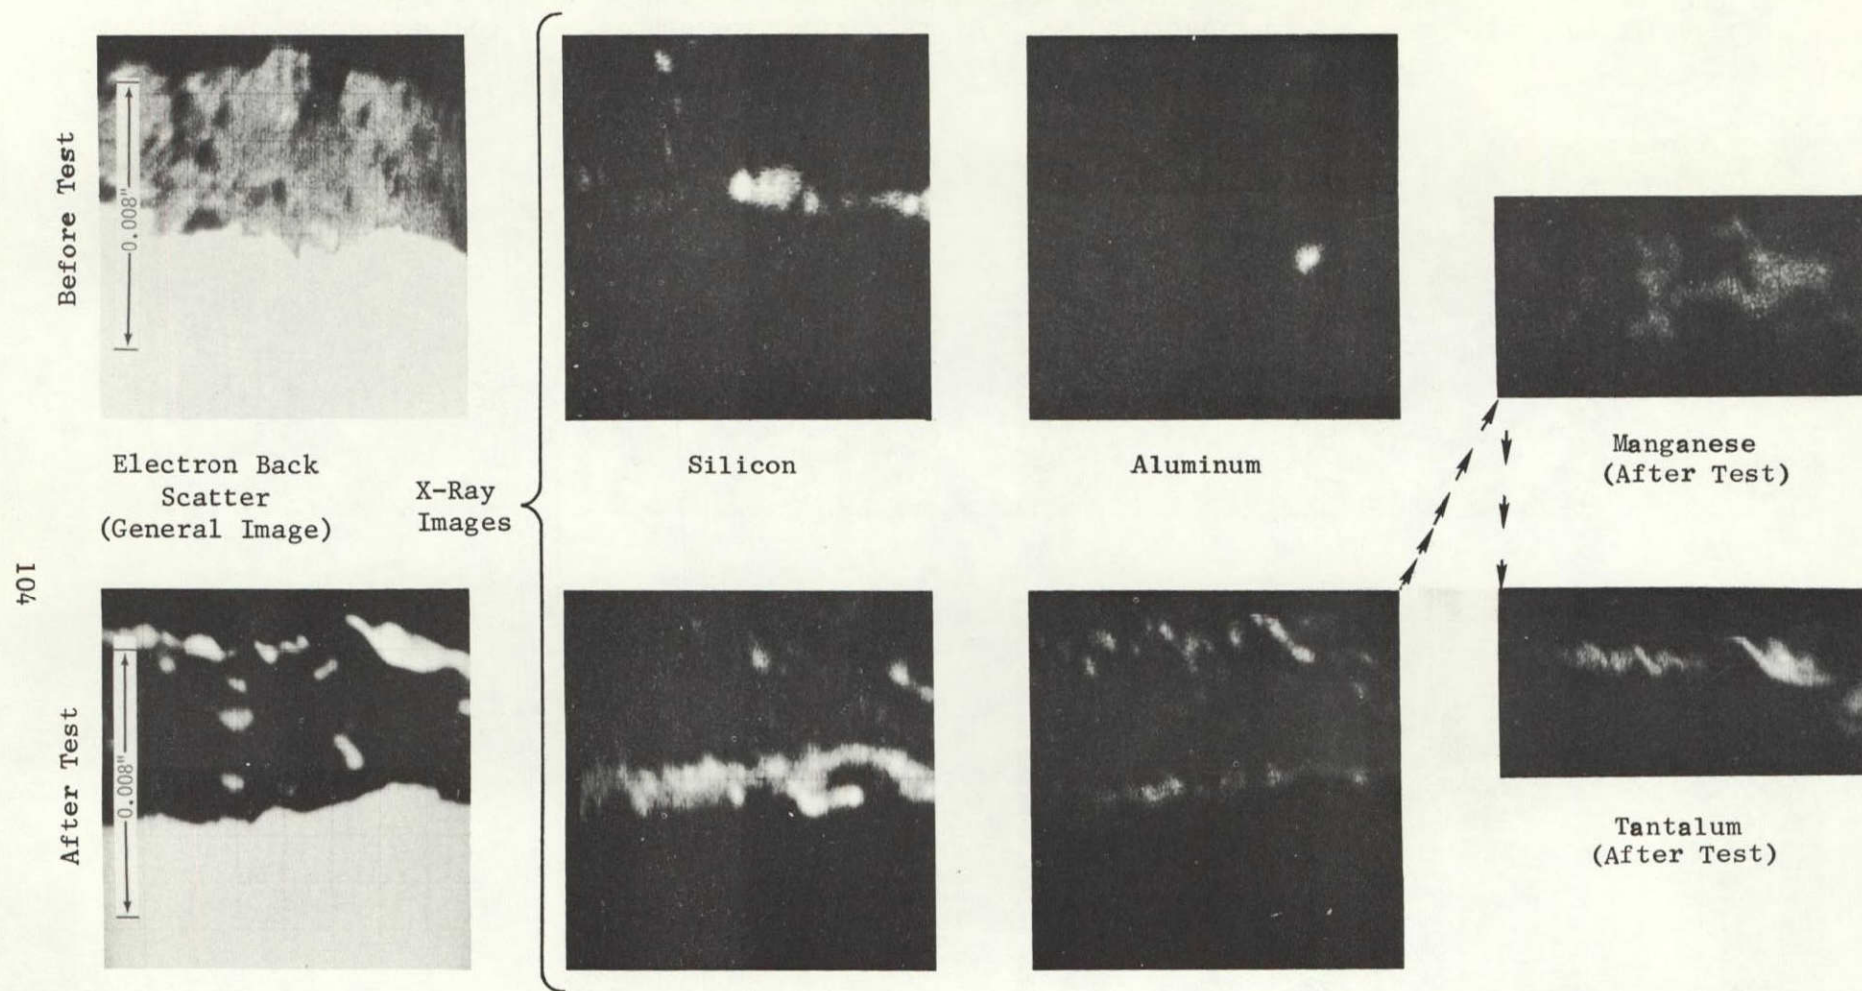
Figure 61. Electron Microprobe Oscillograms Showing the Distribution of Elements in Iron Titanate Coated Cb-1Zr. Specimens were Removed from the Wall of Bellows Capsule II After 3000 Hours of Testing - 1875 Thermal Cycles Between 1500 and 1700^o F.

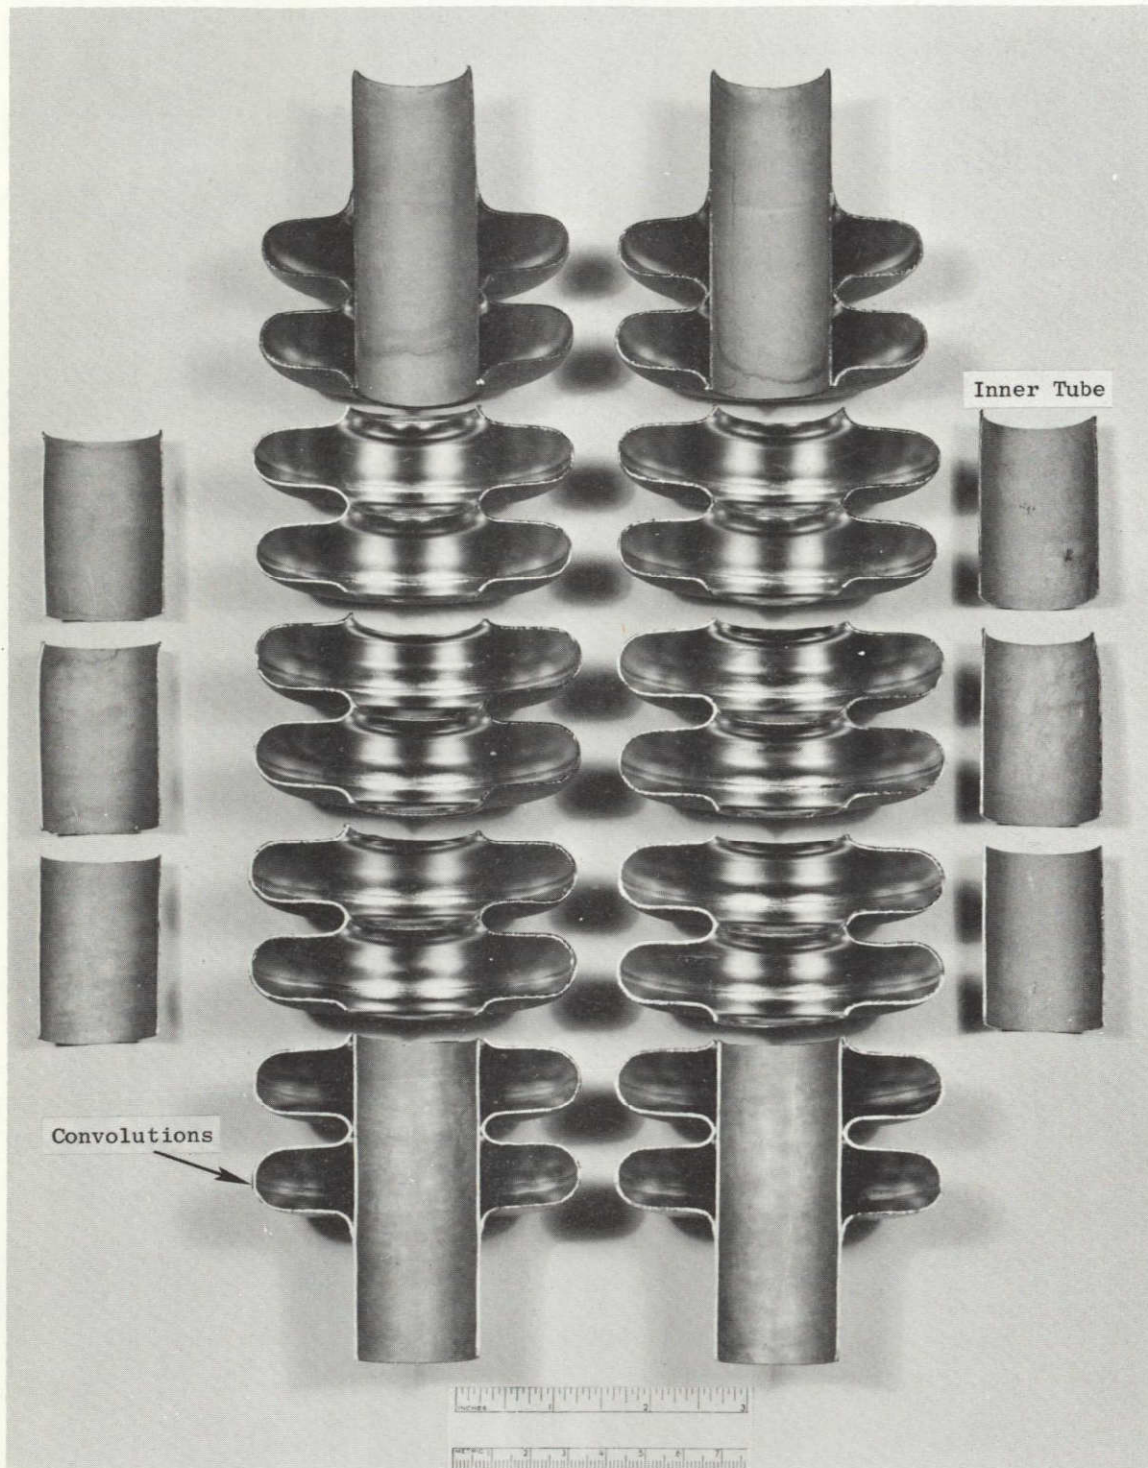
Figure 62. Lithium Fluoride Bellows Capsule III Sectioned After 5000 Hours of Testing. The Residual Lithium Fluoride was Removed from the Cb-1Zr Capsule with Hot Water. (69-10-25B)

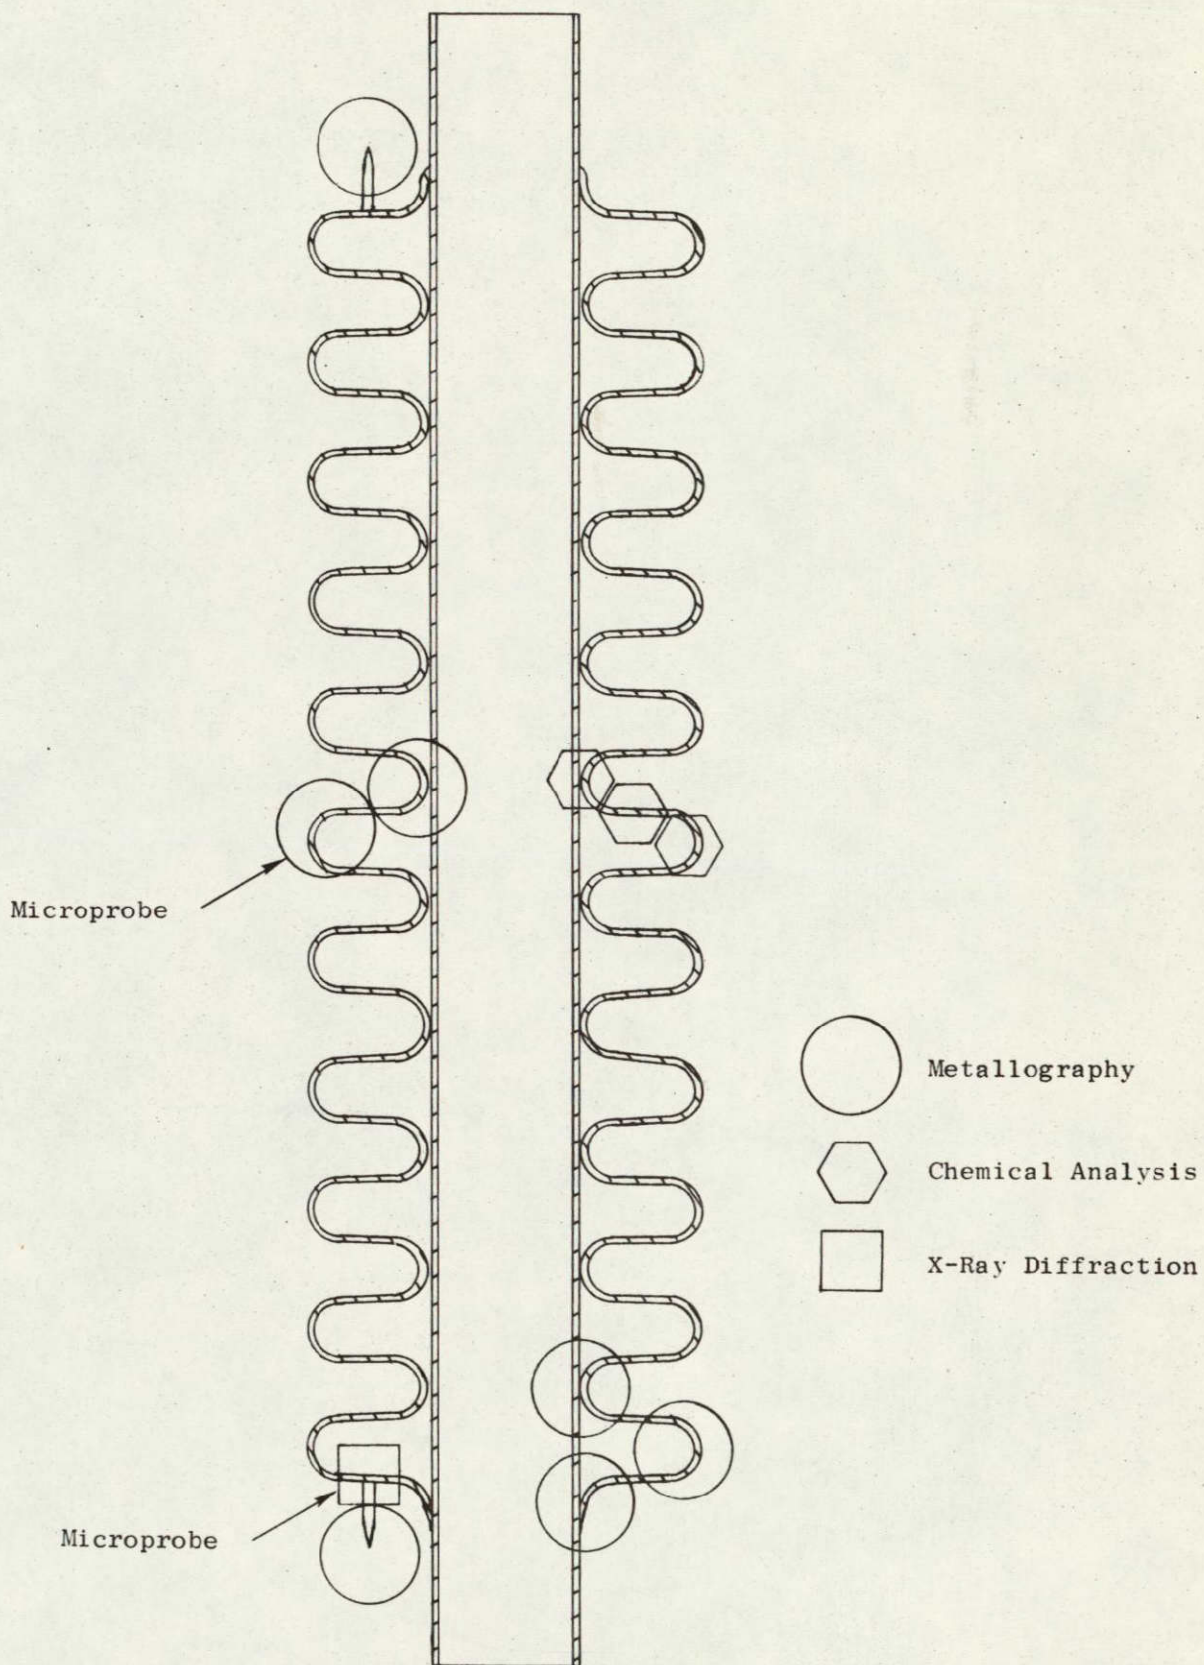
Figure 63. Location of Posttest Evaluation Specimens Taken from Bellows Capsule III.

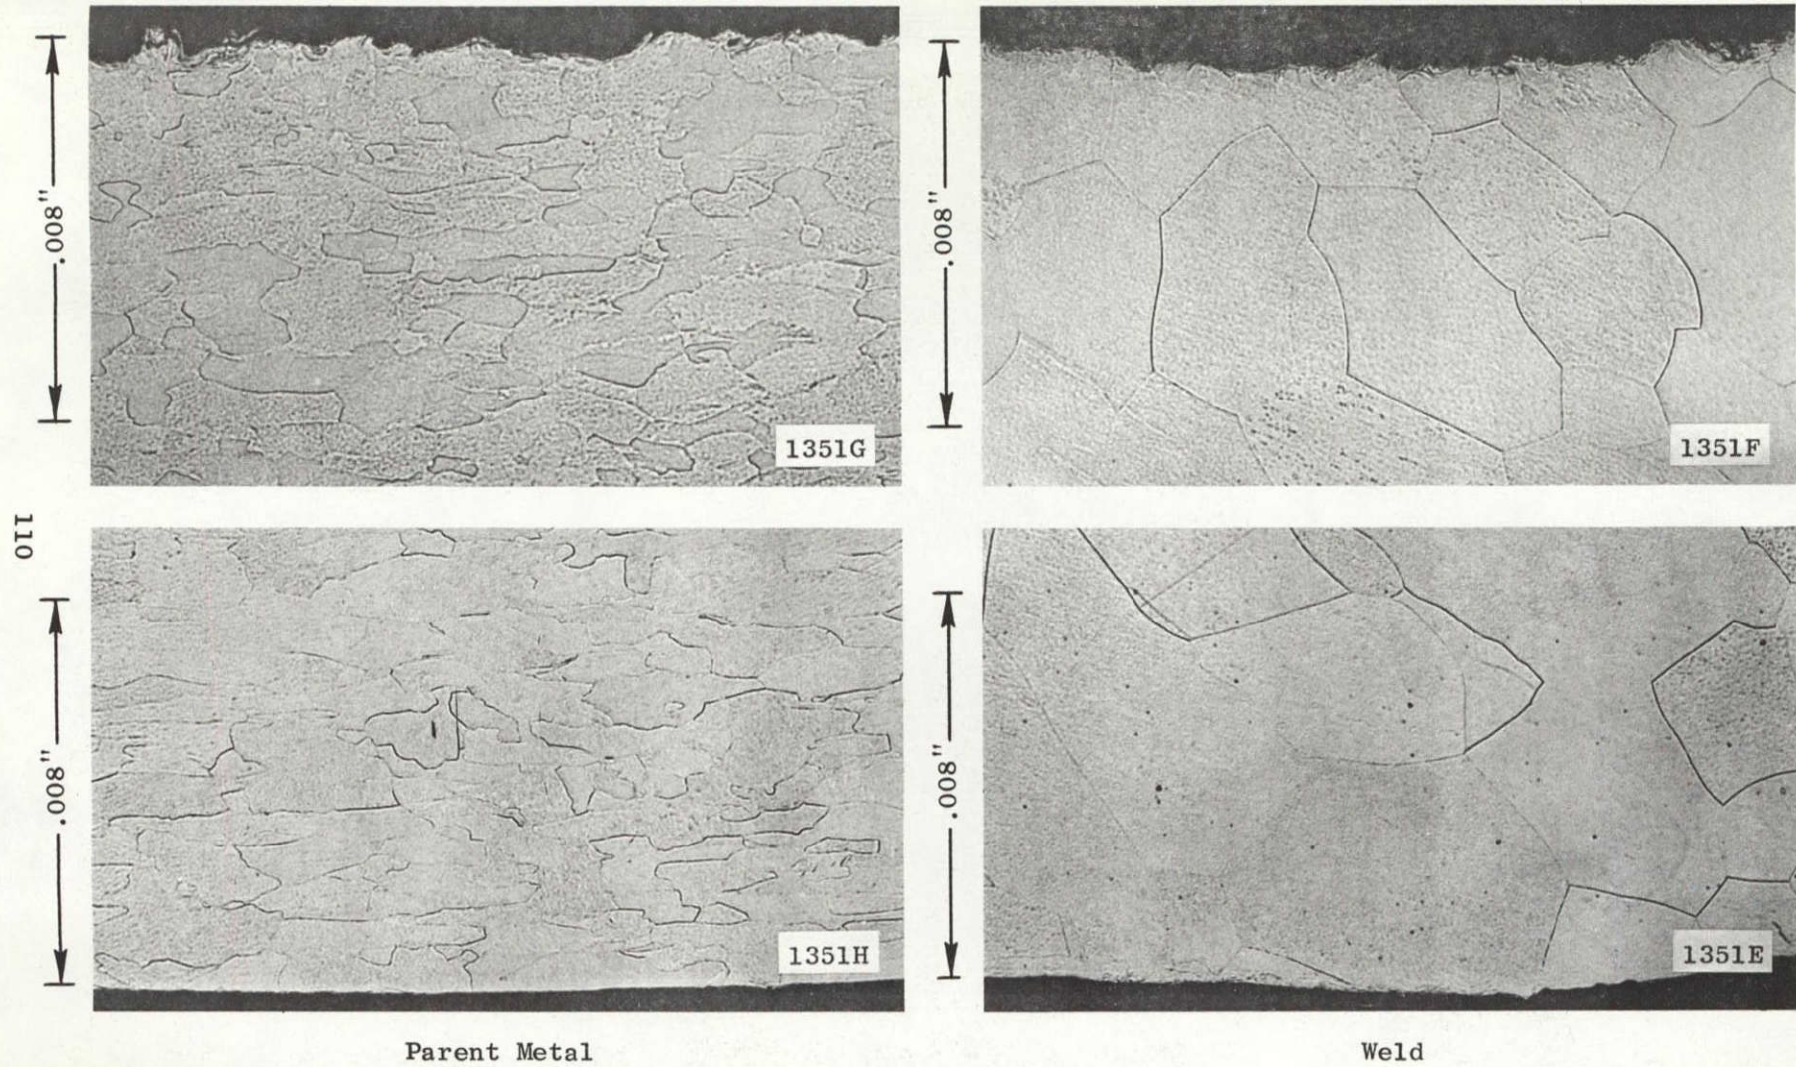
Figure 64. Photomicrographs of Pretest Cb-1Zr Specimen After Gritblasting with Al_2O_3 in the Same Manner as the Bellows Capsule III. Etchant: 60% Glycerin, 20% HNO_3 , 20% HF.

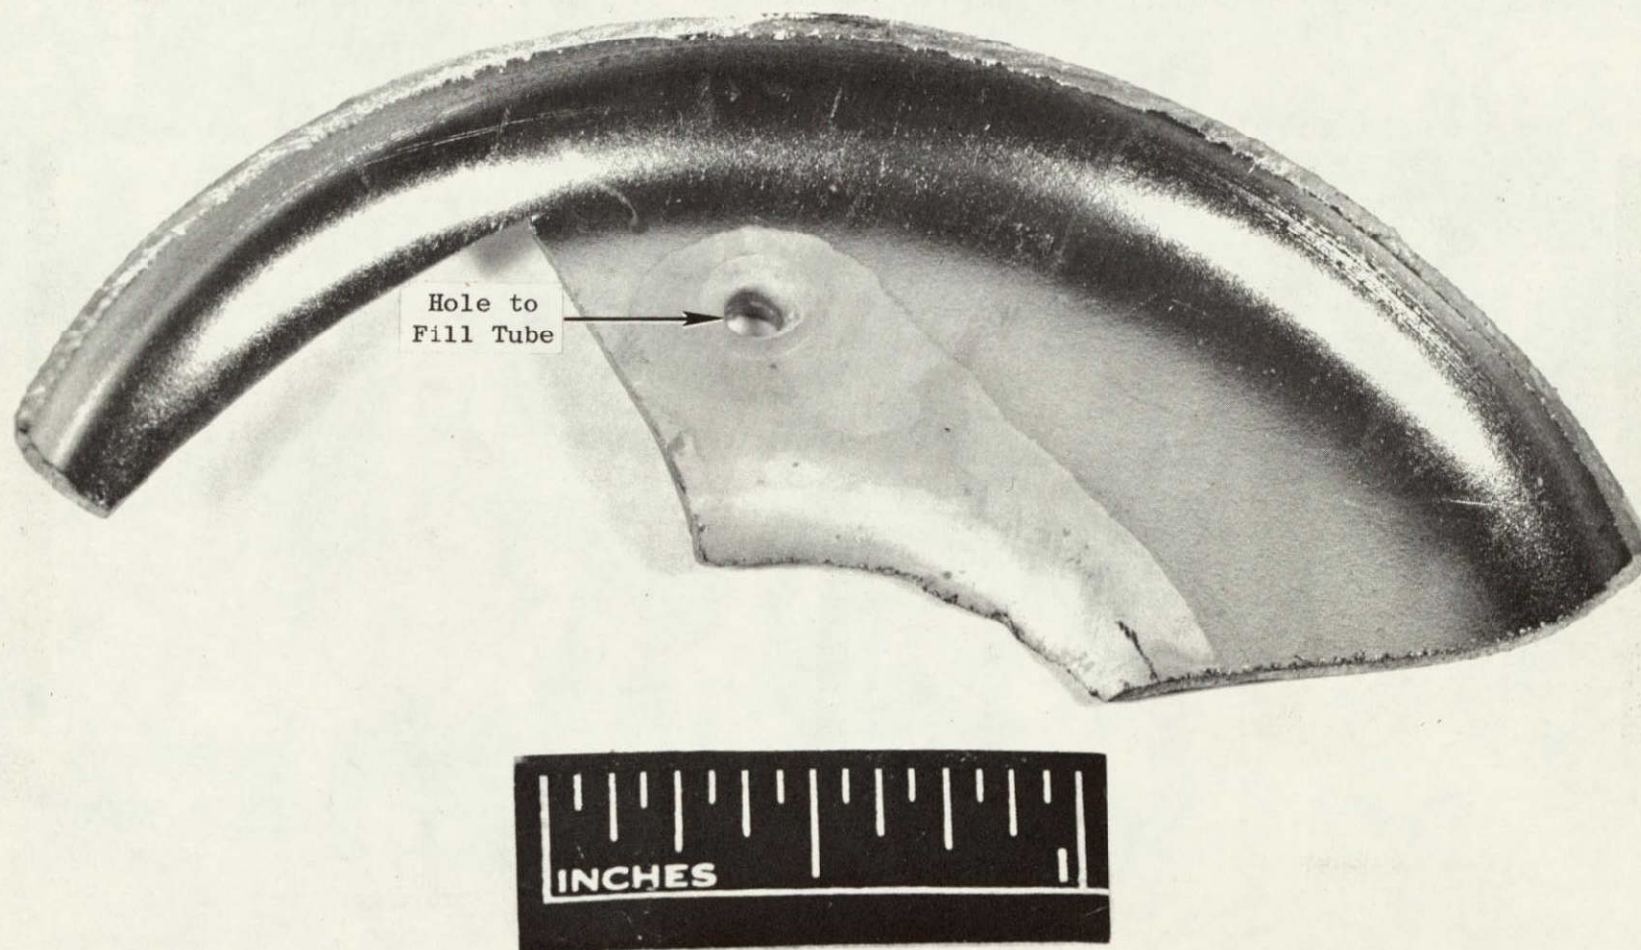
Figure 67. Contaminated Area Around Upper Fill Tube and Top Convolution of Bellows Capsule III. The Surface Phase was Identified as a Cb-O-N Compound. (P69-12-7)

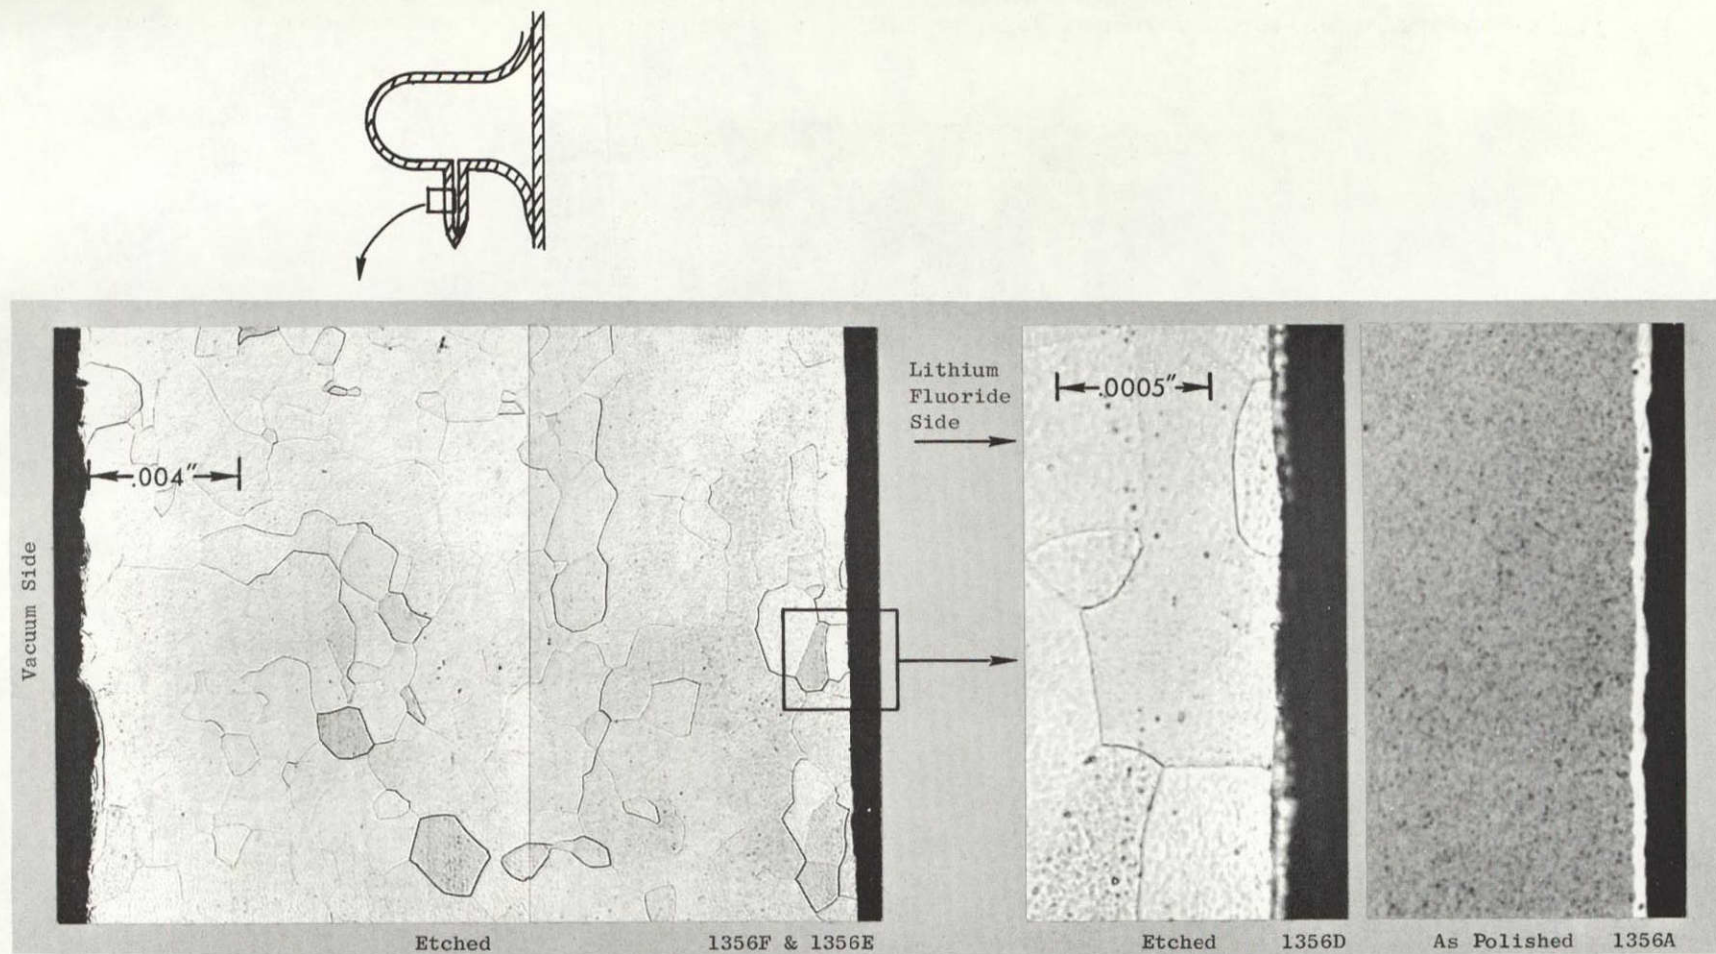
Figure 68. Photomicrographs of Fill Tube From Bellows Capsule III After 5000 Hours Test Time.
